The Impact of Gully Erosion on the Residents of Kontagora, Niger State

¹Iwalaiye Elizabeth Mayokun (Ph.D) & ²Arowolo Jacob Gbemiga (Ph.D)

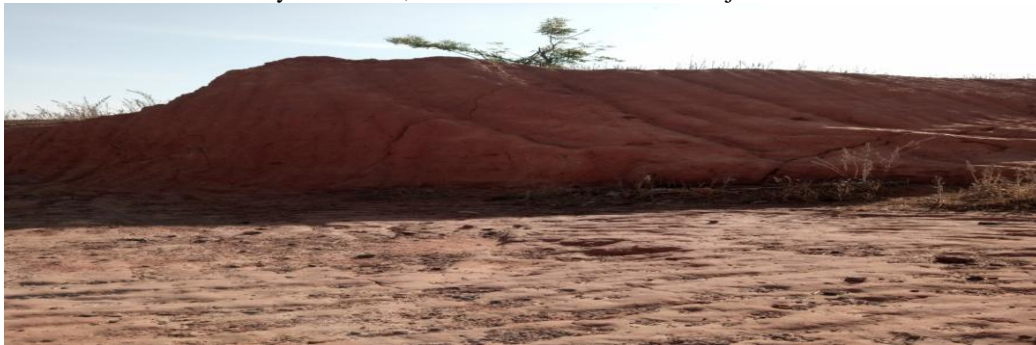
1. Behind Abuja Electricity Distribution Corporation AEDC along Federal College of Education (FCE) road, in Kontagora: This is site A, in figure 2, it is selected because the site is used for molding of mud blocks and sand excavation during the rainy season. It is a rock formed as a result of accumulation of sand and stones. The red soil of the rock is clayey and very good for molding of blocks this is why human activities of this kind takes place there. During the rainy season the exposed soil is vulnerable to erosion and being excavated for sand filling eroded areas in the community. Human factor is the major cause.

Figure 2: A Mud block industry behind AEDC (Site A)

Human activities of mud block making has affected the area thereby making it vulnerable to erosion, the area has a wide pit as a result of excavation and digging out of soil for construction purposes. An observation behind old market also shows that the area is influence by human activities of modern block making and irrigation farming. These Anthropogenic factors combine to weakened soils to produce severe gullies. The soils are hence loose and slumps under high intensive rainfall that renders them easily detachable. Some of the soils have the tendency to slake and form seals under such intense rainstorms thereby resulting in considerable runoff and soil

As observed in table 1, site A has the width of 49m, height of 6m, length of 50m and depth of 10m. Site B has the width of 10m, height of 1.2m, length of 56m and depth of 1.3m. Site C has the width of 41m, height of 2.45m, length of 100m and depth of 2.85m. Site D has the width of 5m, height of 0.70m, length of 39m and depth of 1m.

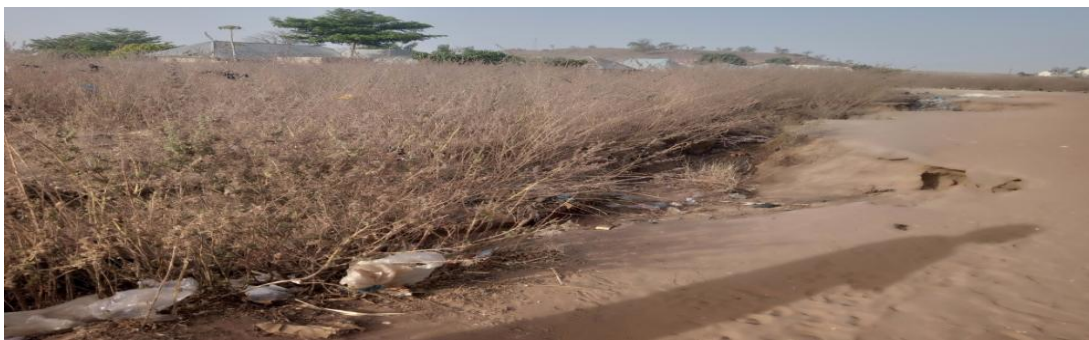
Figure 3: A damaged road beside UBE primary school, old Kwangwara (Site B)

2. Along Universal Basic Education (UBE) primary school at old kwangwara: This is site B, it is selected because the area is along a minor road surrounded by houses. The area is seen in figure 3; it is known to be vulnerable to erosion due to the local

geologic setting, the permeability, porosity, cohesion and hydrodynamic events in the area. The gully erosion menace is thriving as a result of absence of well-coordinated control measures and inadequate and urgent attention it deserves.

From the above table, it is observed that site C beside FCEK fence has the longest length 100m, it is observed that the length extended to a long distance and collapsed a minor road which is now abandoned for only foot parts and used for waste land where cabbages, excreta and refuse are littered. More so, foundations of buildings along this part are collapsed. Site A has the deepest depth of 10m. This is as a result of continuous excavation of mud soil for block making and for sand filling over a long period of time which has finally led to a gully. In essence it has the highest height of 6m this shows how high the hill is. The gully in site B of old Kwangwara UBE primary school road has a peculiarity because the gully is formed on the road where humans and cars pass.

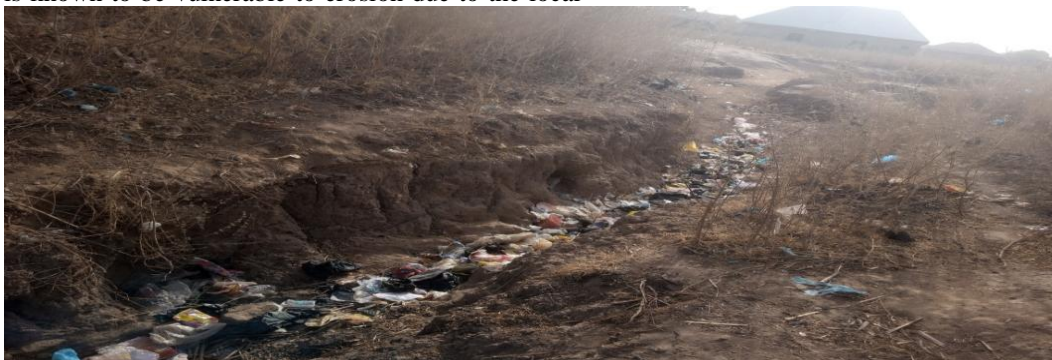
Figure 4: A damaged road beside FCE Kontagora fence (Site C)

3. Beside Federal College of Education (FCE) fence: This is site C, as observed in figure 4, it is within clustered settlement beside FCE fence and it is occupied by residents of staff and students of the college. Due to the porosity of the soil geology run-

off played significant role in gulling, runoff at vulnerable region where there is poor drainage shows elevation changes within valley slopes which is observed in this site.

By observation, it is concluded that the gully is a result of natural and human cause. The soil type is very porous and it lacks drainage pattern. There is a threat on the road presently because it could collapse at any time if control measures are not taken. The peculiarity in site D is that, it is found beside a bridge, irrigation farm and modern block industry where the soil is threatened by all this human

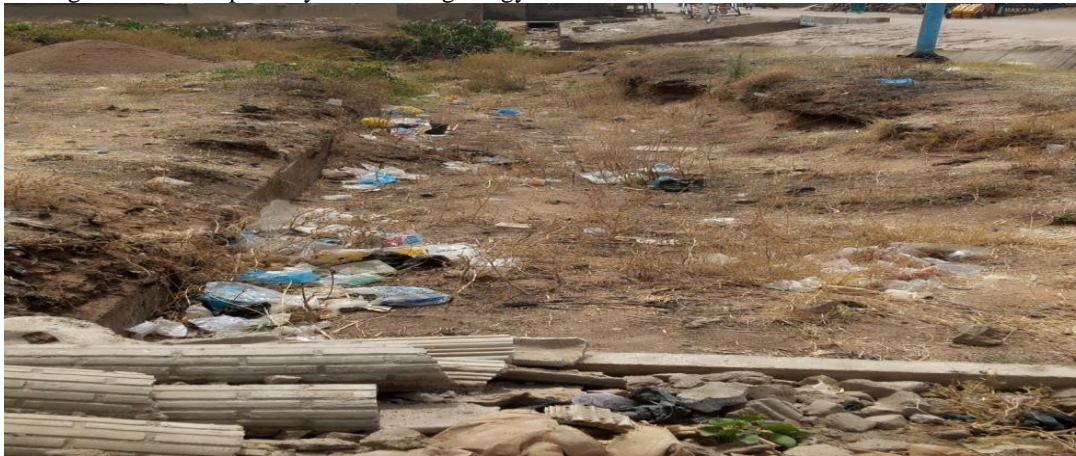
Figure 5: A modern block making industry with gully erosion behind old market (Site D)

4. Behind Old Market: This is site D, it is selected because it is within clustered settlement dominated by the indigenes of Kontagora behind old market as seen in figure 5. The areas has poor drainage pattern and it is also characterized by human activities such as modern block making and irrigation farming. Refuse are also dumped and cabbages litter around known as 'bolla' in Hausa language.

activities, and because of the geology of the soil, the soil is easily loosened and eroded.
